INTEROFFICE MEMORANDUM
Transportation Division

Clark County, Washington
Department of Public
Works

TO: Michael Mabrey
FROM: Ejaz Khan, P.E.; Traffic Engineer EK
DATE: December 26, 2013
SUBJECT: Livingston Mountain Quarry Overlay District.

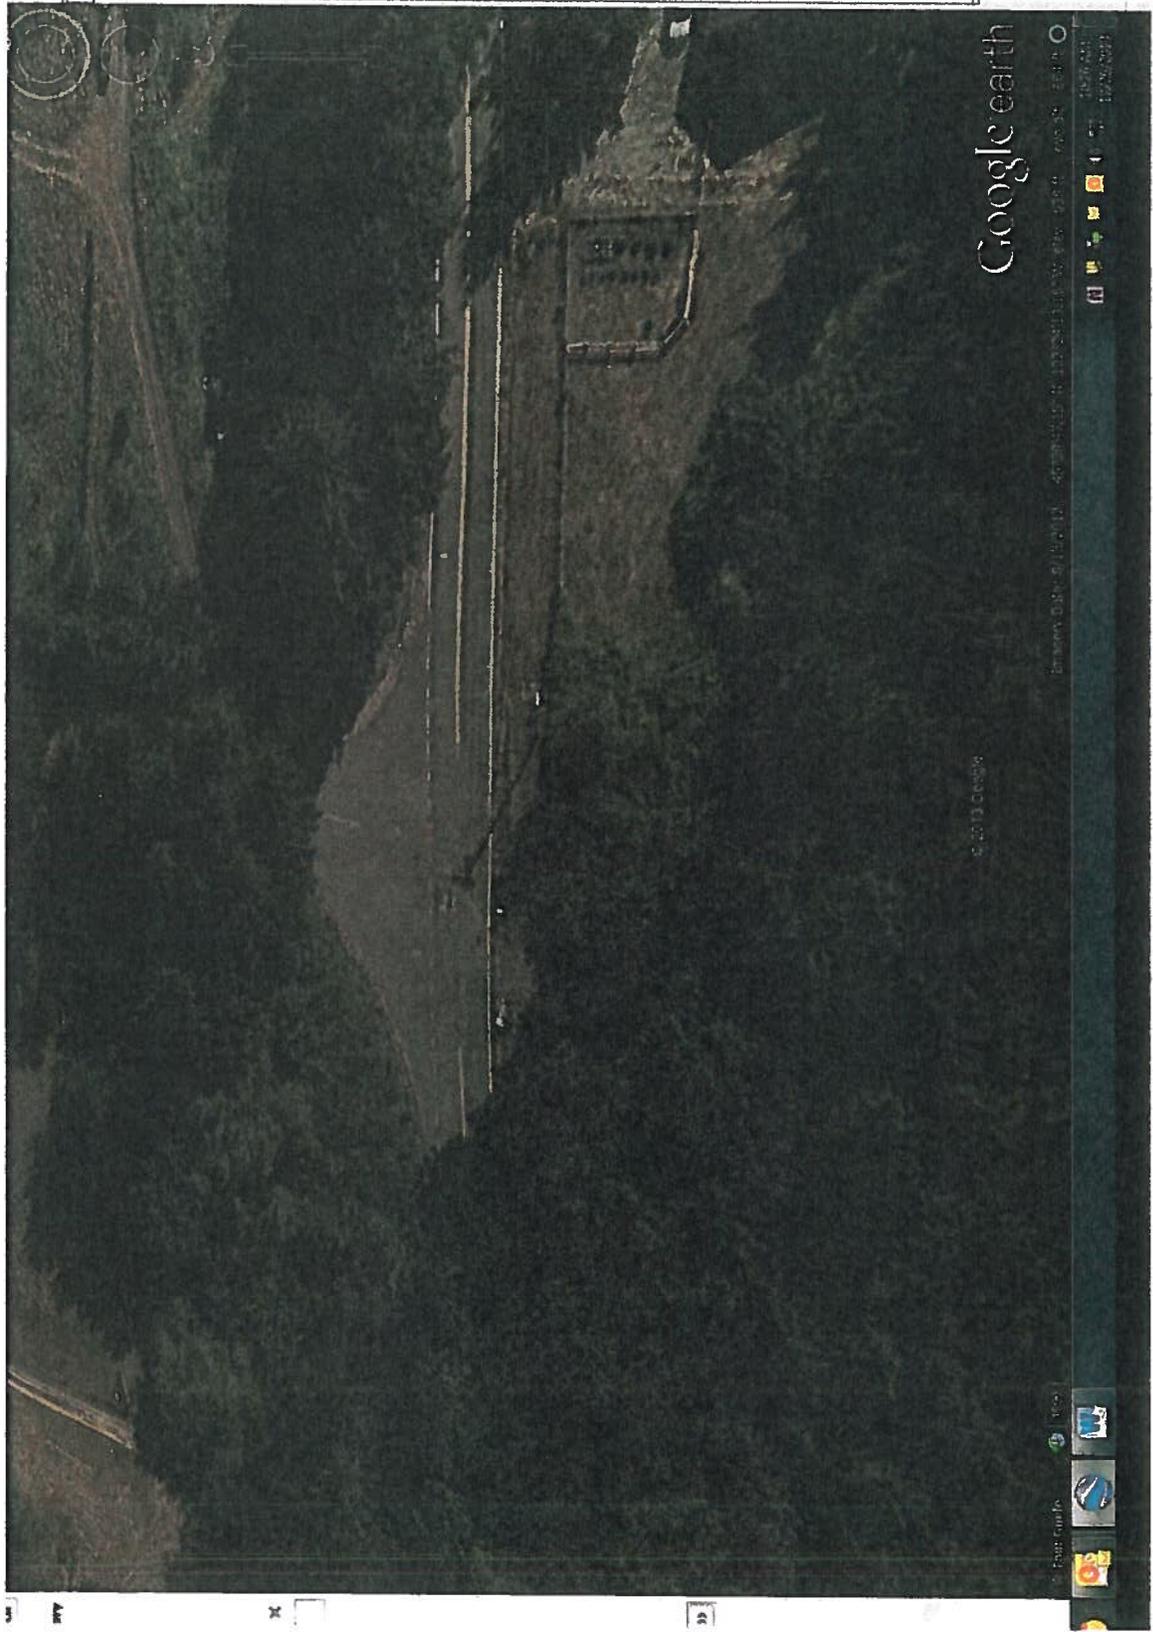
NE 262nd Avenue at Bradford Road- Aerial View

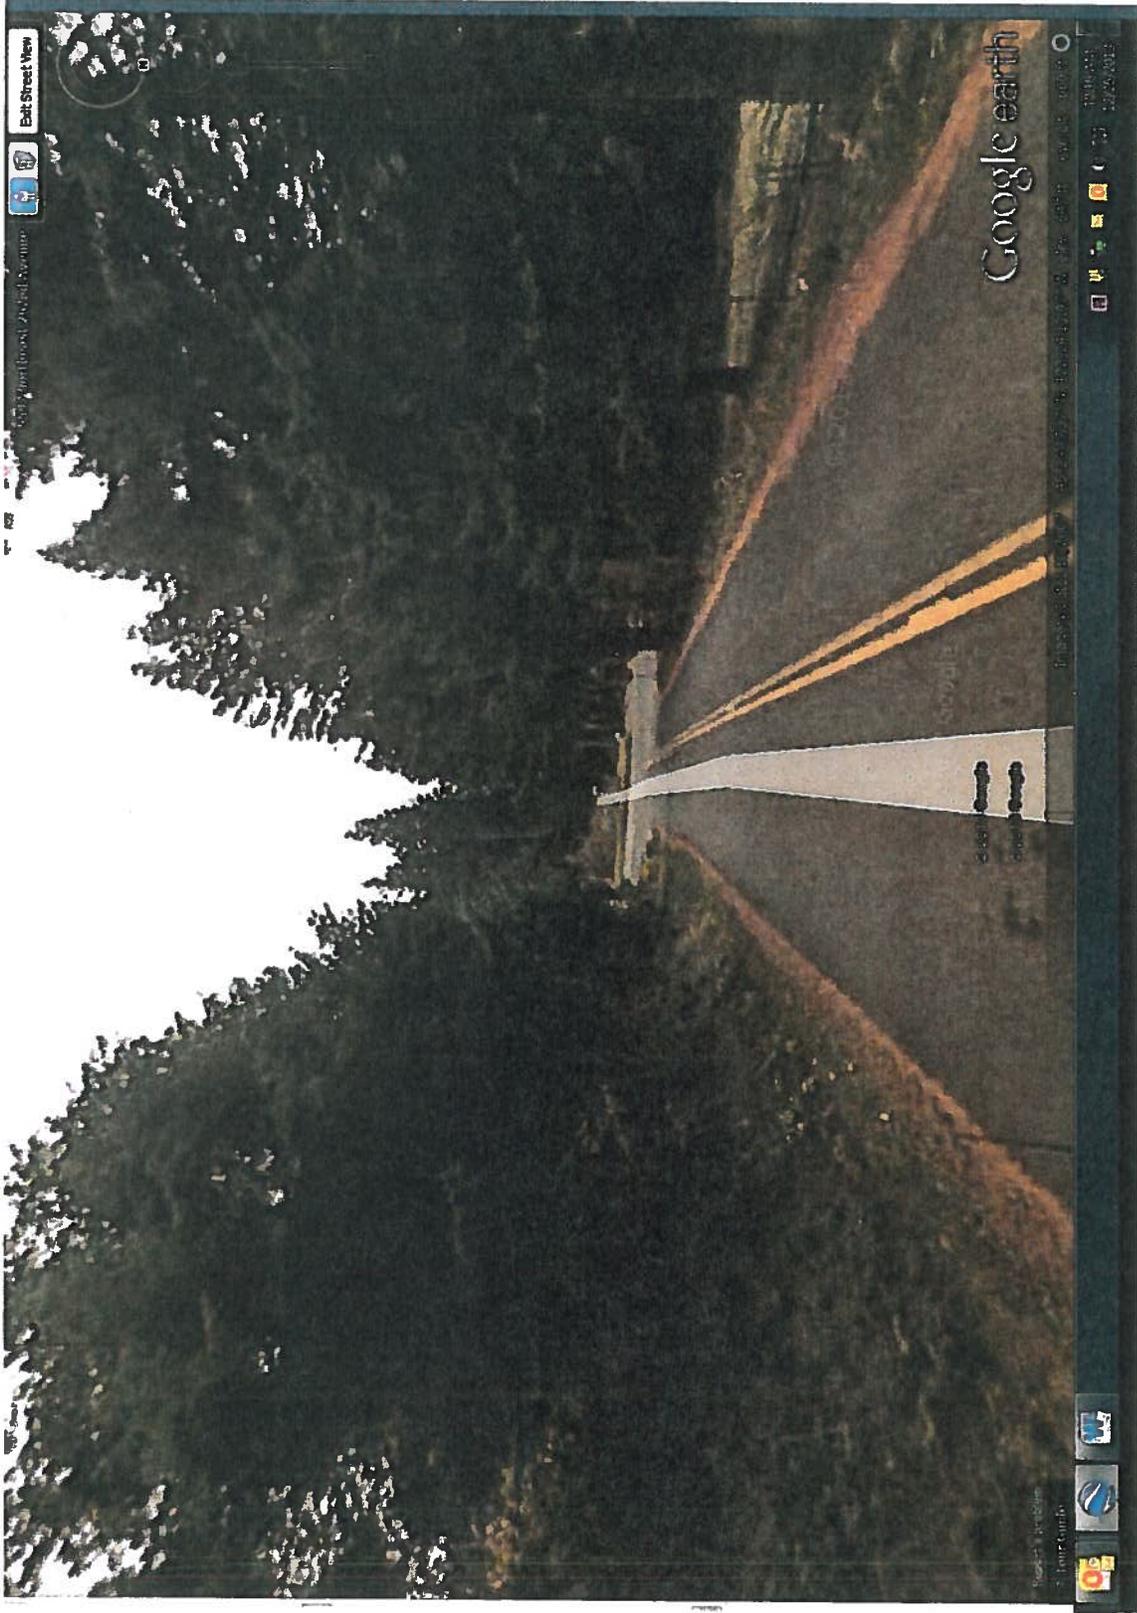
The NE 262nd Avenue intersection with Bradford Road is controlled via a STOP sign. The STOP control for NE 262nd Avenue is visible to the approaching driver, driving a passenger vehicle, from a distance of 800 feet. This would be adequate distance to bring a vehicle to a safe stop. Additionally a "STOP AHEAD" warning sign precedes the STOP control sign. NE 262nd Avenue approaching Bradford Road is on a downhill grade. Steps could be taken to further improve the traffic safety at the intersection. The safety improvements are narrated in the conclusion and recommendation section of this report.

NE 262nd Avenue at Bradford Road looking South

6. The geometric layout NE 262nd Avenue at its intersection with Bradford Road will allow for safe ingress and egress movement for gravel trucks.
7. The Stop sign on NE 262nd Avenue at Bradford Road is visible from sufficient distance to allow a safe stop. However, removal to two trees in the immediate vicinity of the STOP control will further improve the line of sight and consequently enhance traffic safety.

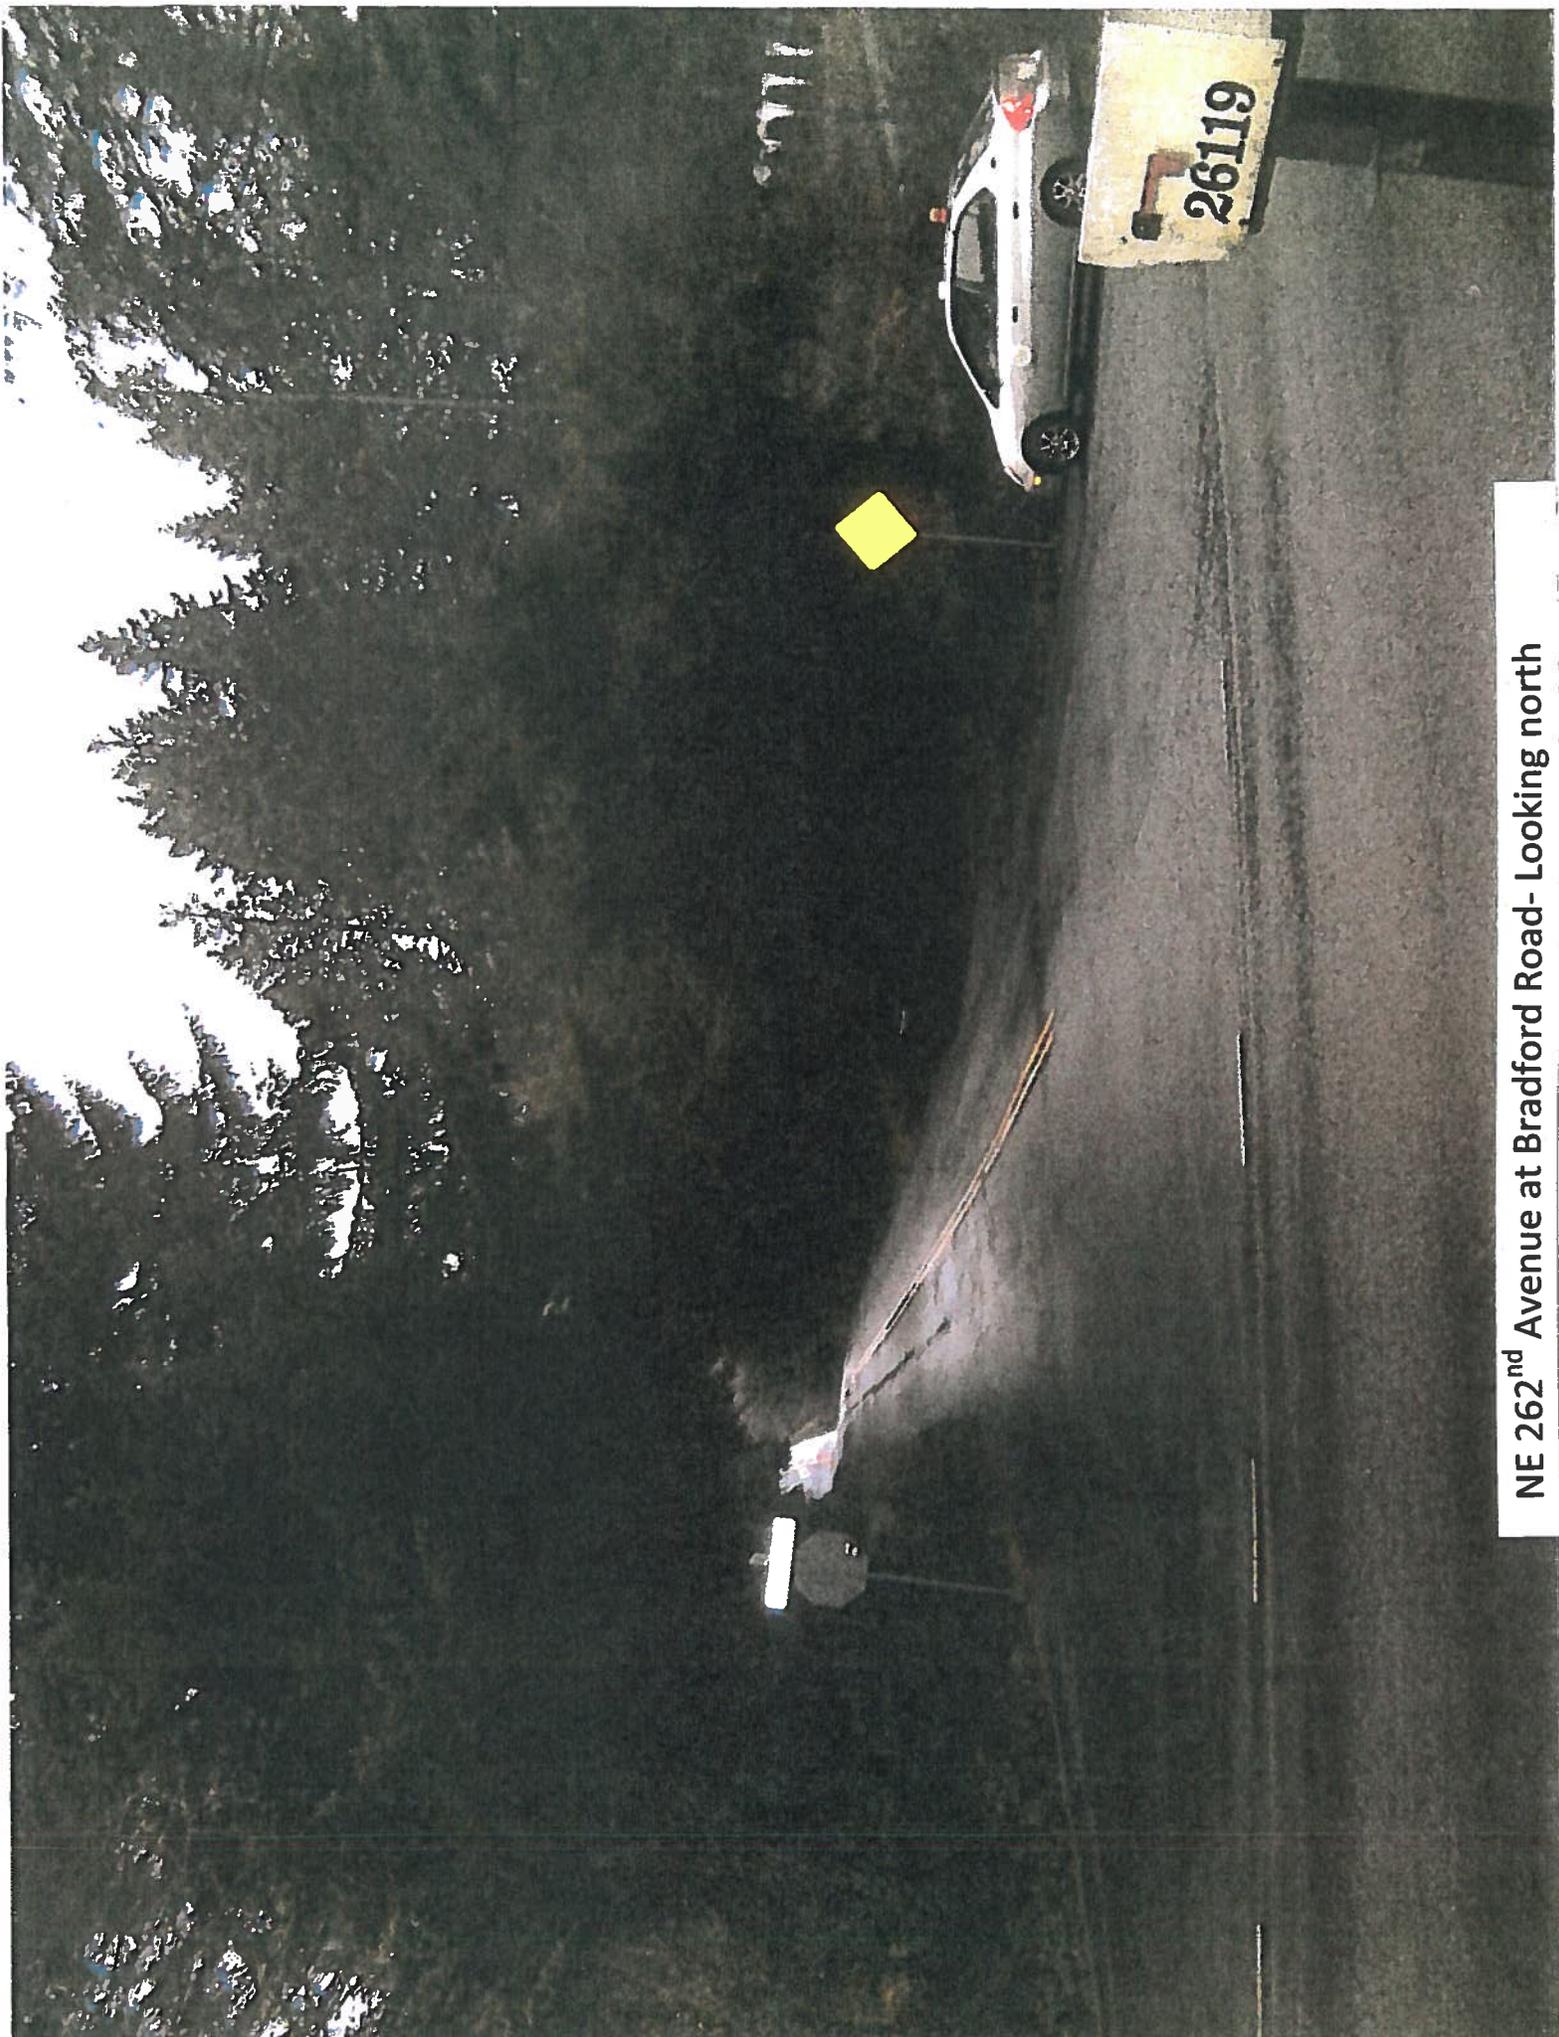
NE 262nd Avenue at Bradford Road- Looking north

8. Since NE 262nd Avenue approaching Bradford Road is on a relatively long negative downhill grade, it is recommended that "Pavement friction management" be implemented at its approach with Bradford Road to ensure a safe stop by a loaded gravel truck.

9. Since NE 262nd Avenue approaching Bradford Road is on a negative downhill grade, it is recommended that the approach with Bradford Road be white topped (cement concrete pavement surface) to prevent southbound loaded gravel trucks from destroying the pavement.

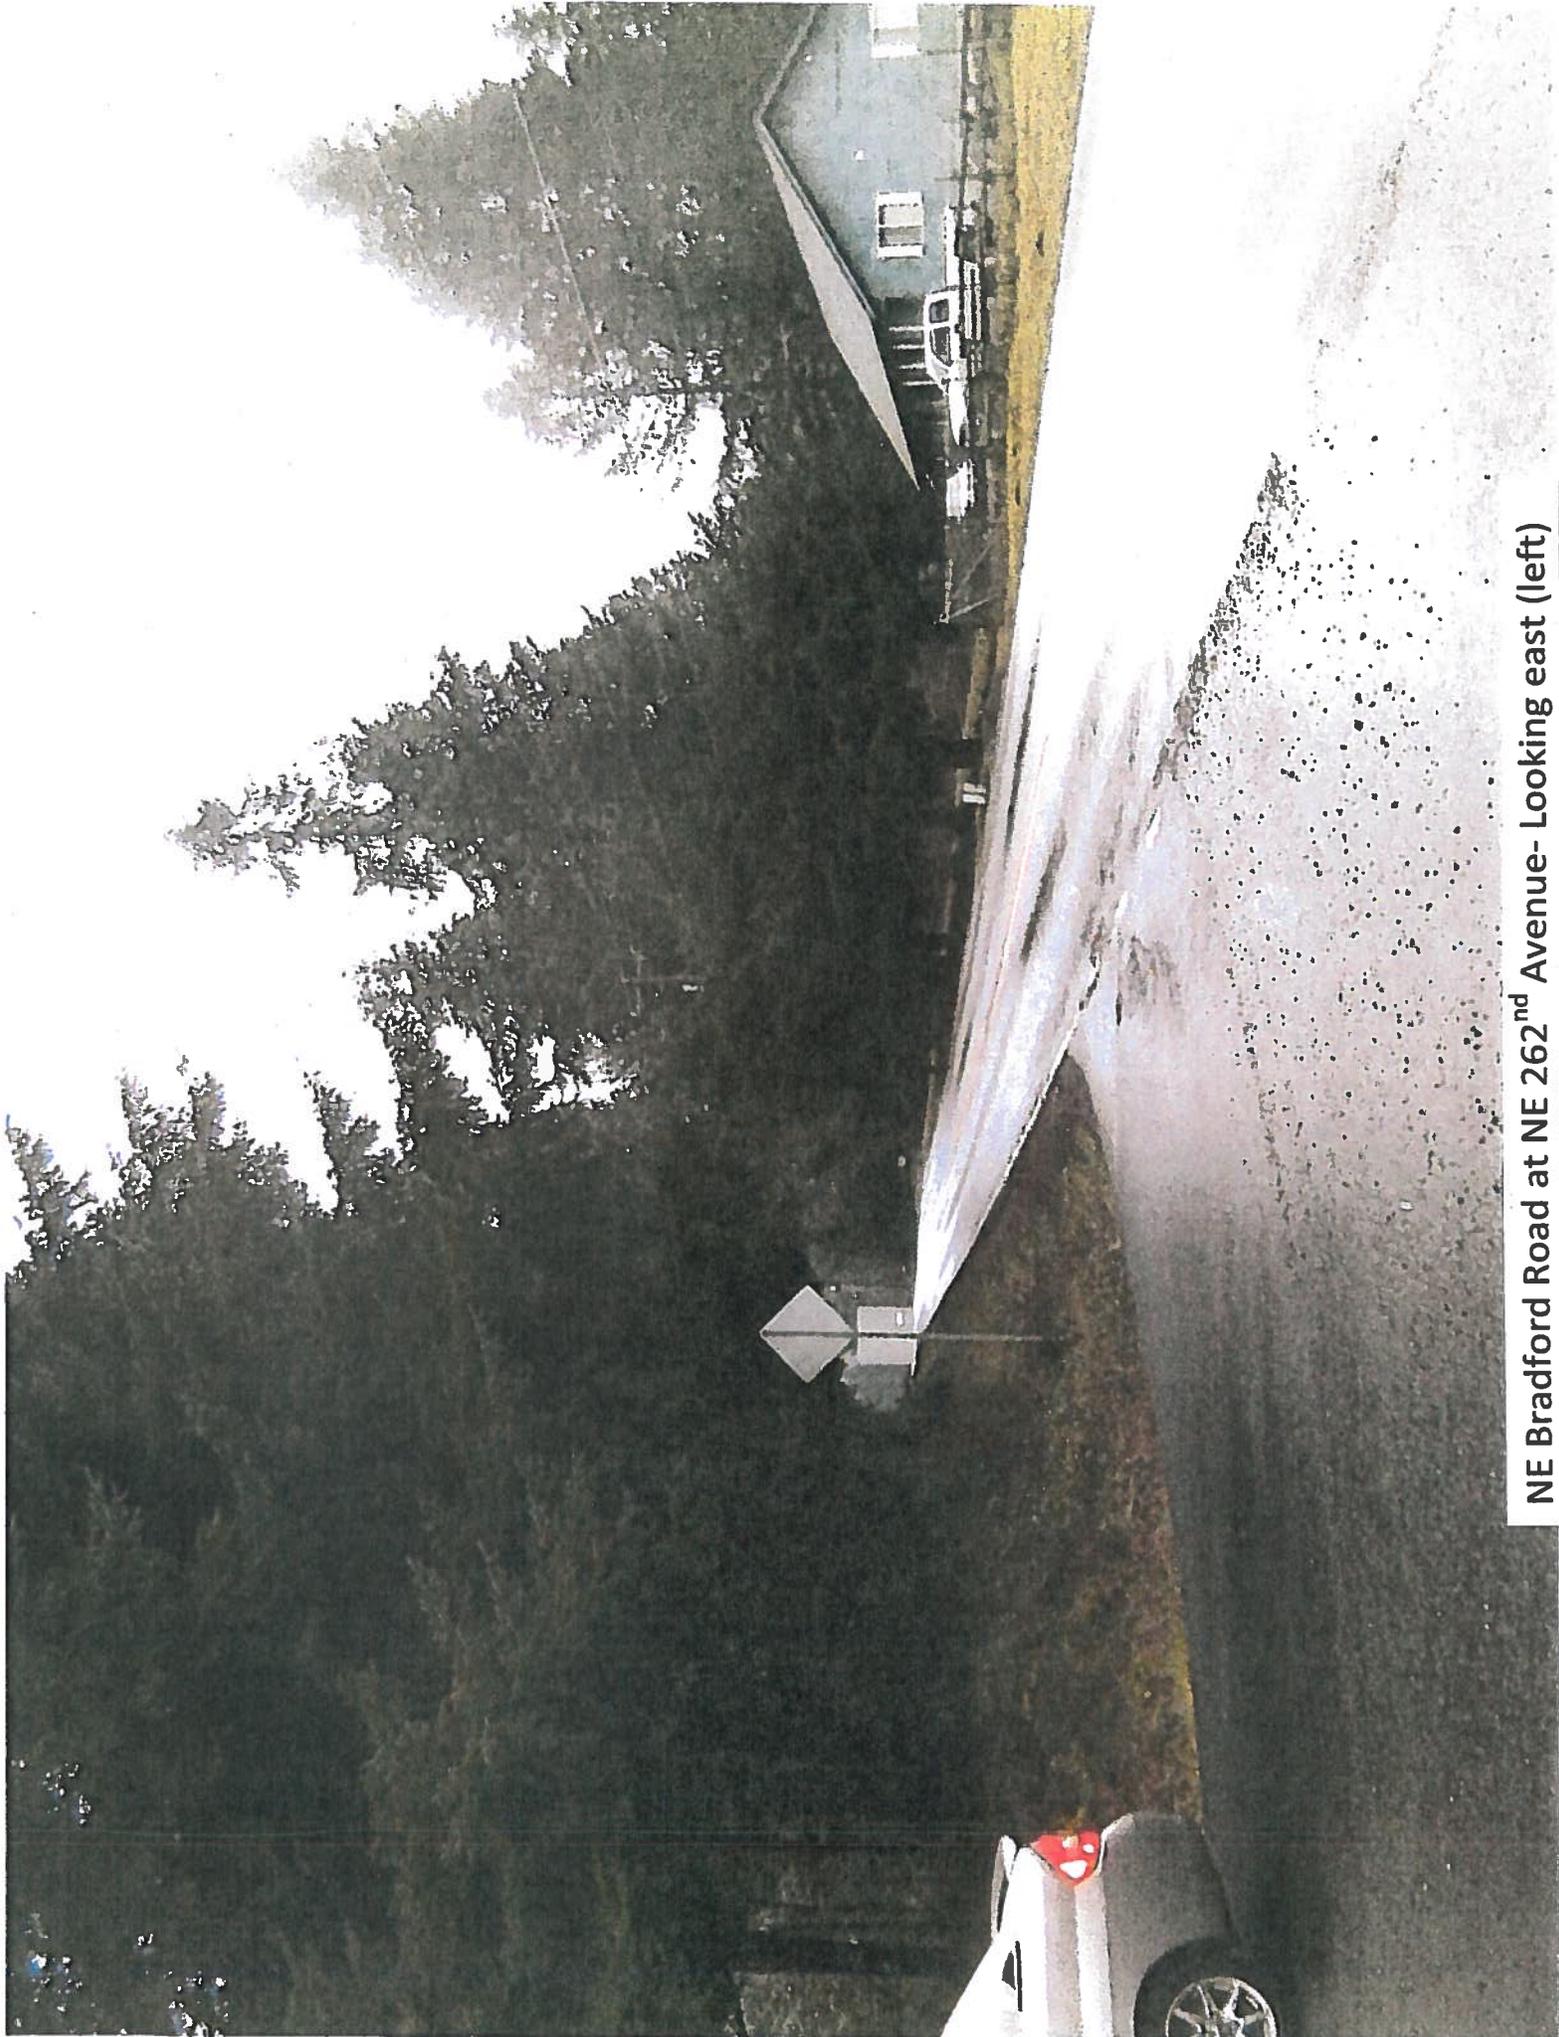
12. The intersection sight distance from NE 262nd Avenue, looking east (left) along Bradford Road was measured as 700 feet. This sight distance meets the minimum requirement for making a right turn out of 362nd Avenue. Note that the 700 feet sight distance was based on driver eye height of 3.5 feet.

NE Bradford Road at NE 262nd Avenue- Looking east (left)

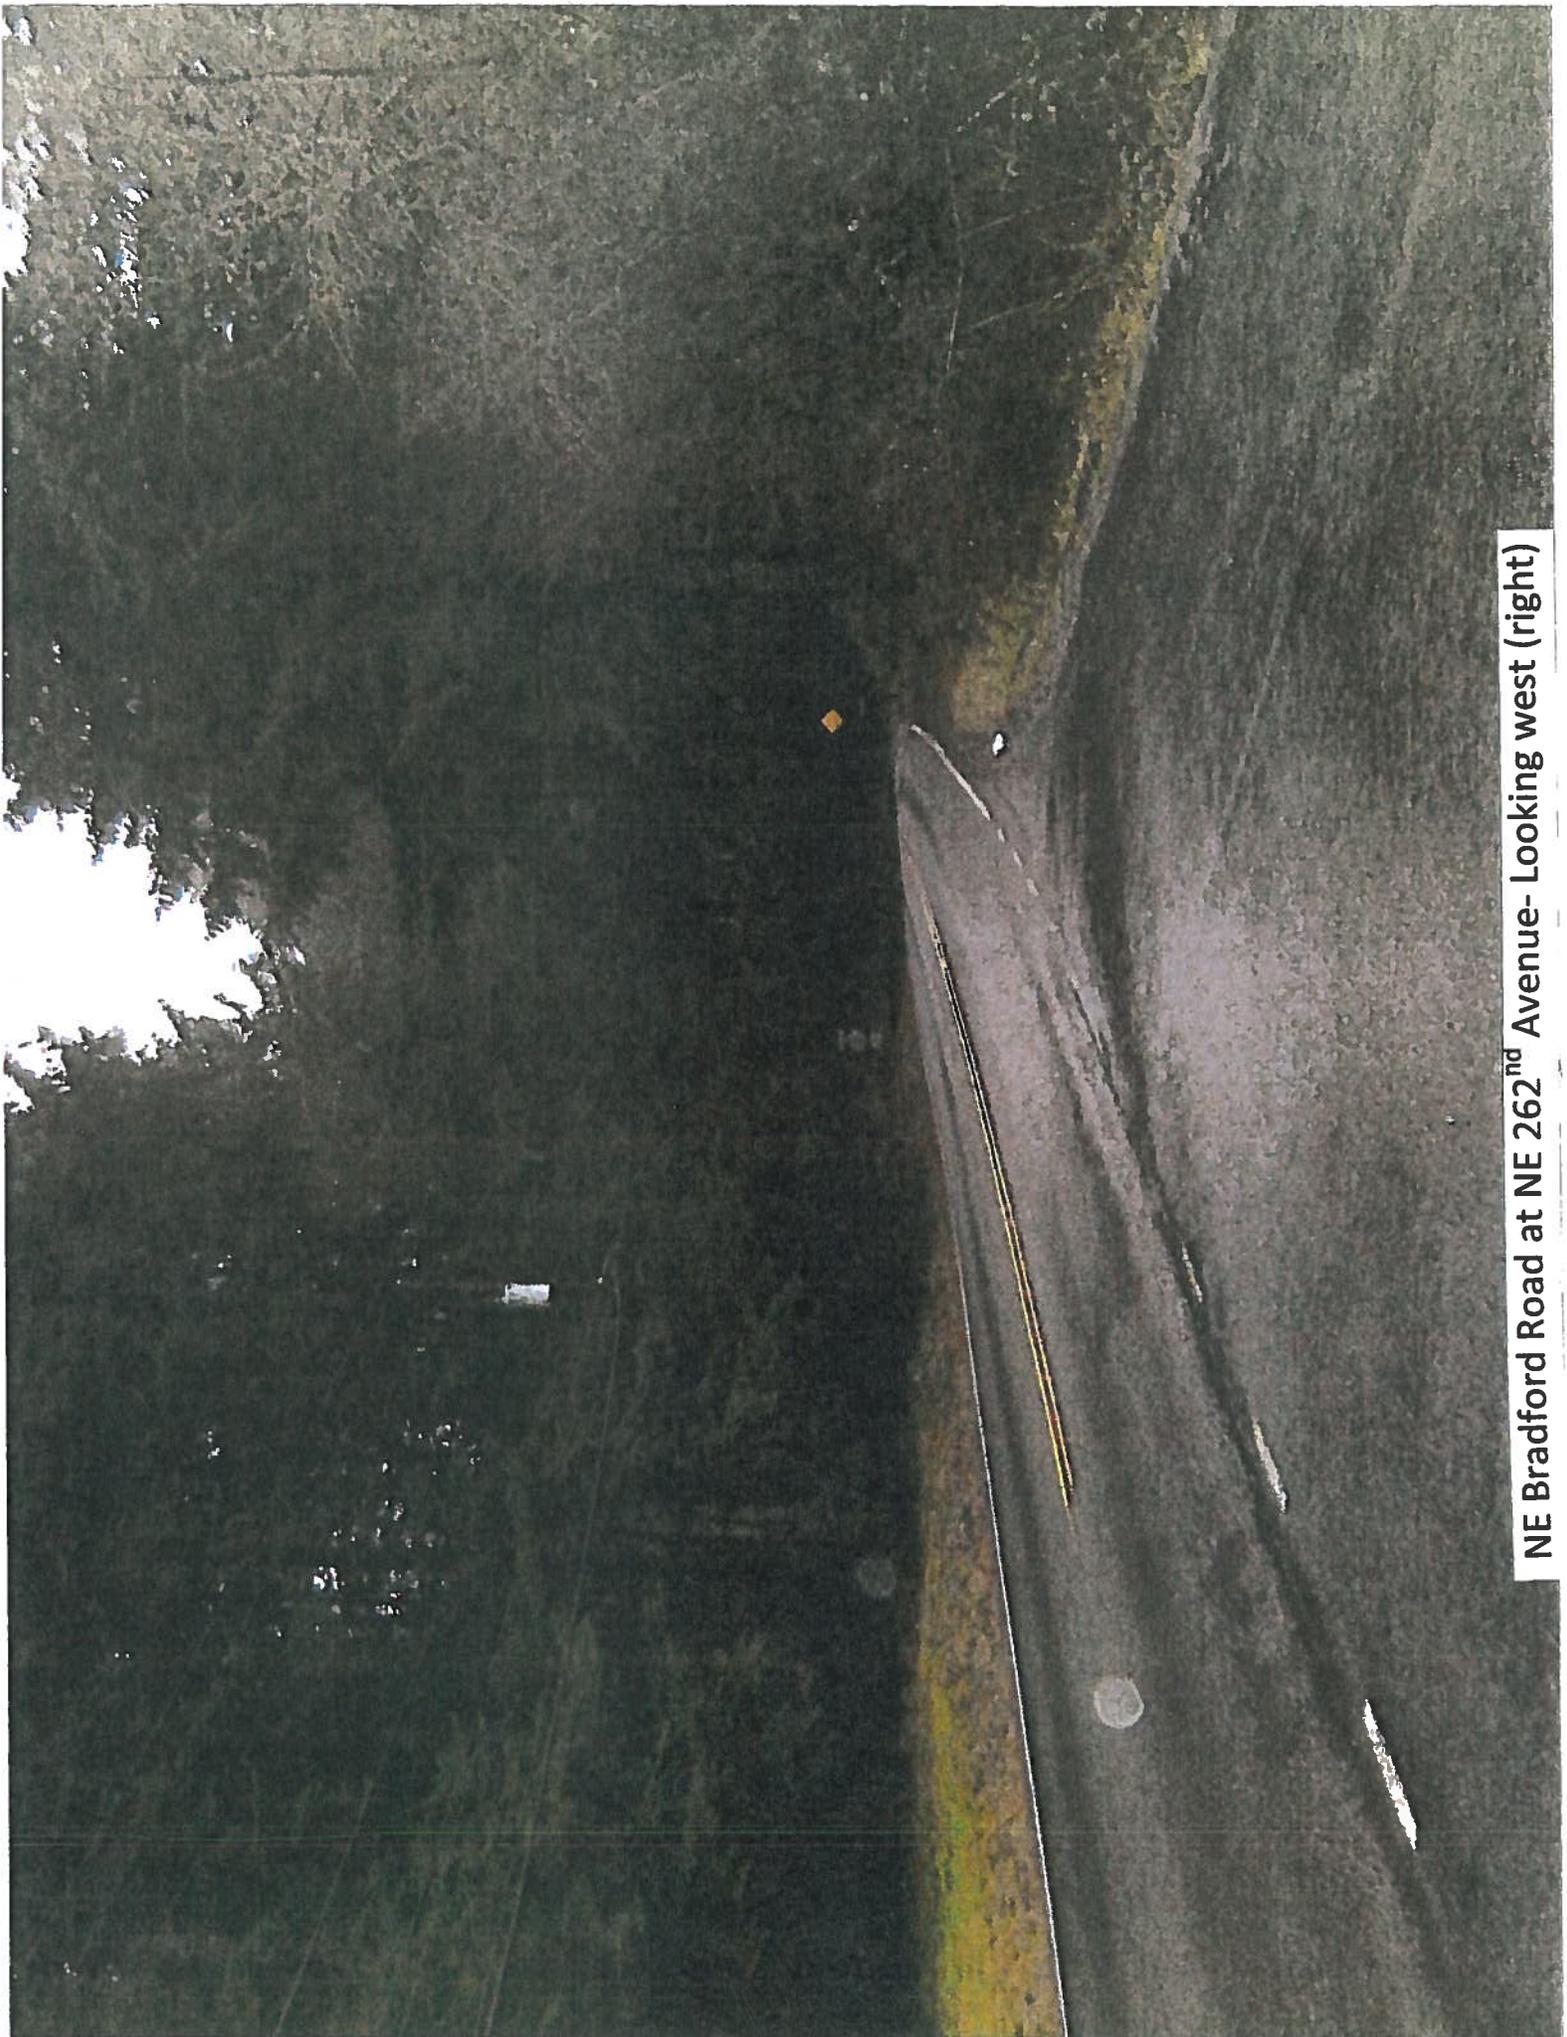
11. The intersection sight distance from NE 262nd Avenue, looking west (right) along Bradford Road was measured as 330 feet. This sight distance is not adequate for a safe left turn out of NE 262nd Avenue. A loaded gravel truck would require a much higher sight distance than the nominal sight distance of ten times the posted speed. A more detailed study would be necessary to determine the necessary intersection sight distance.

NE Bradford Road at NE 262nd Avenue- Looking west (right)

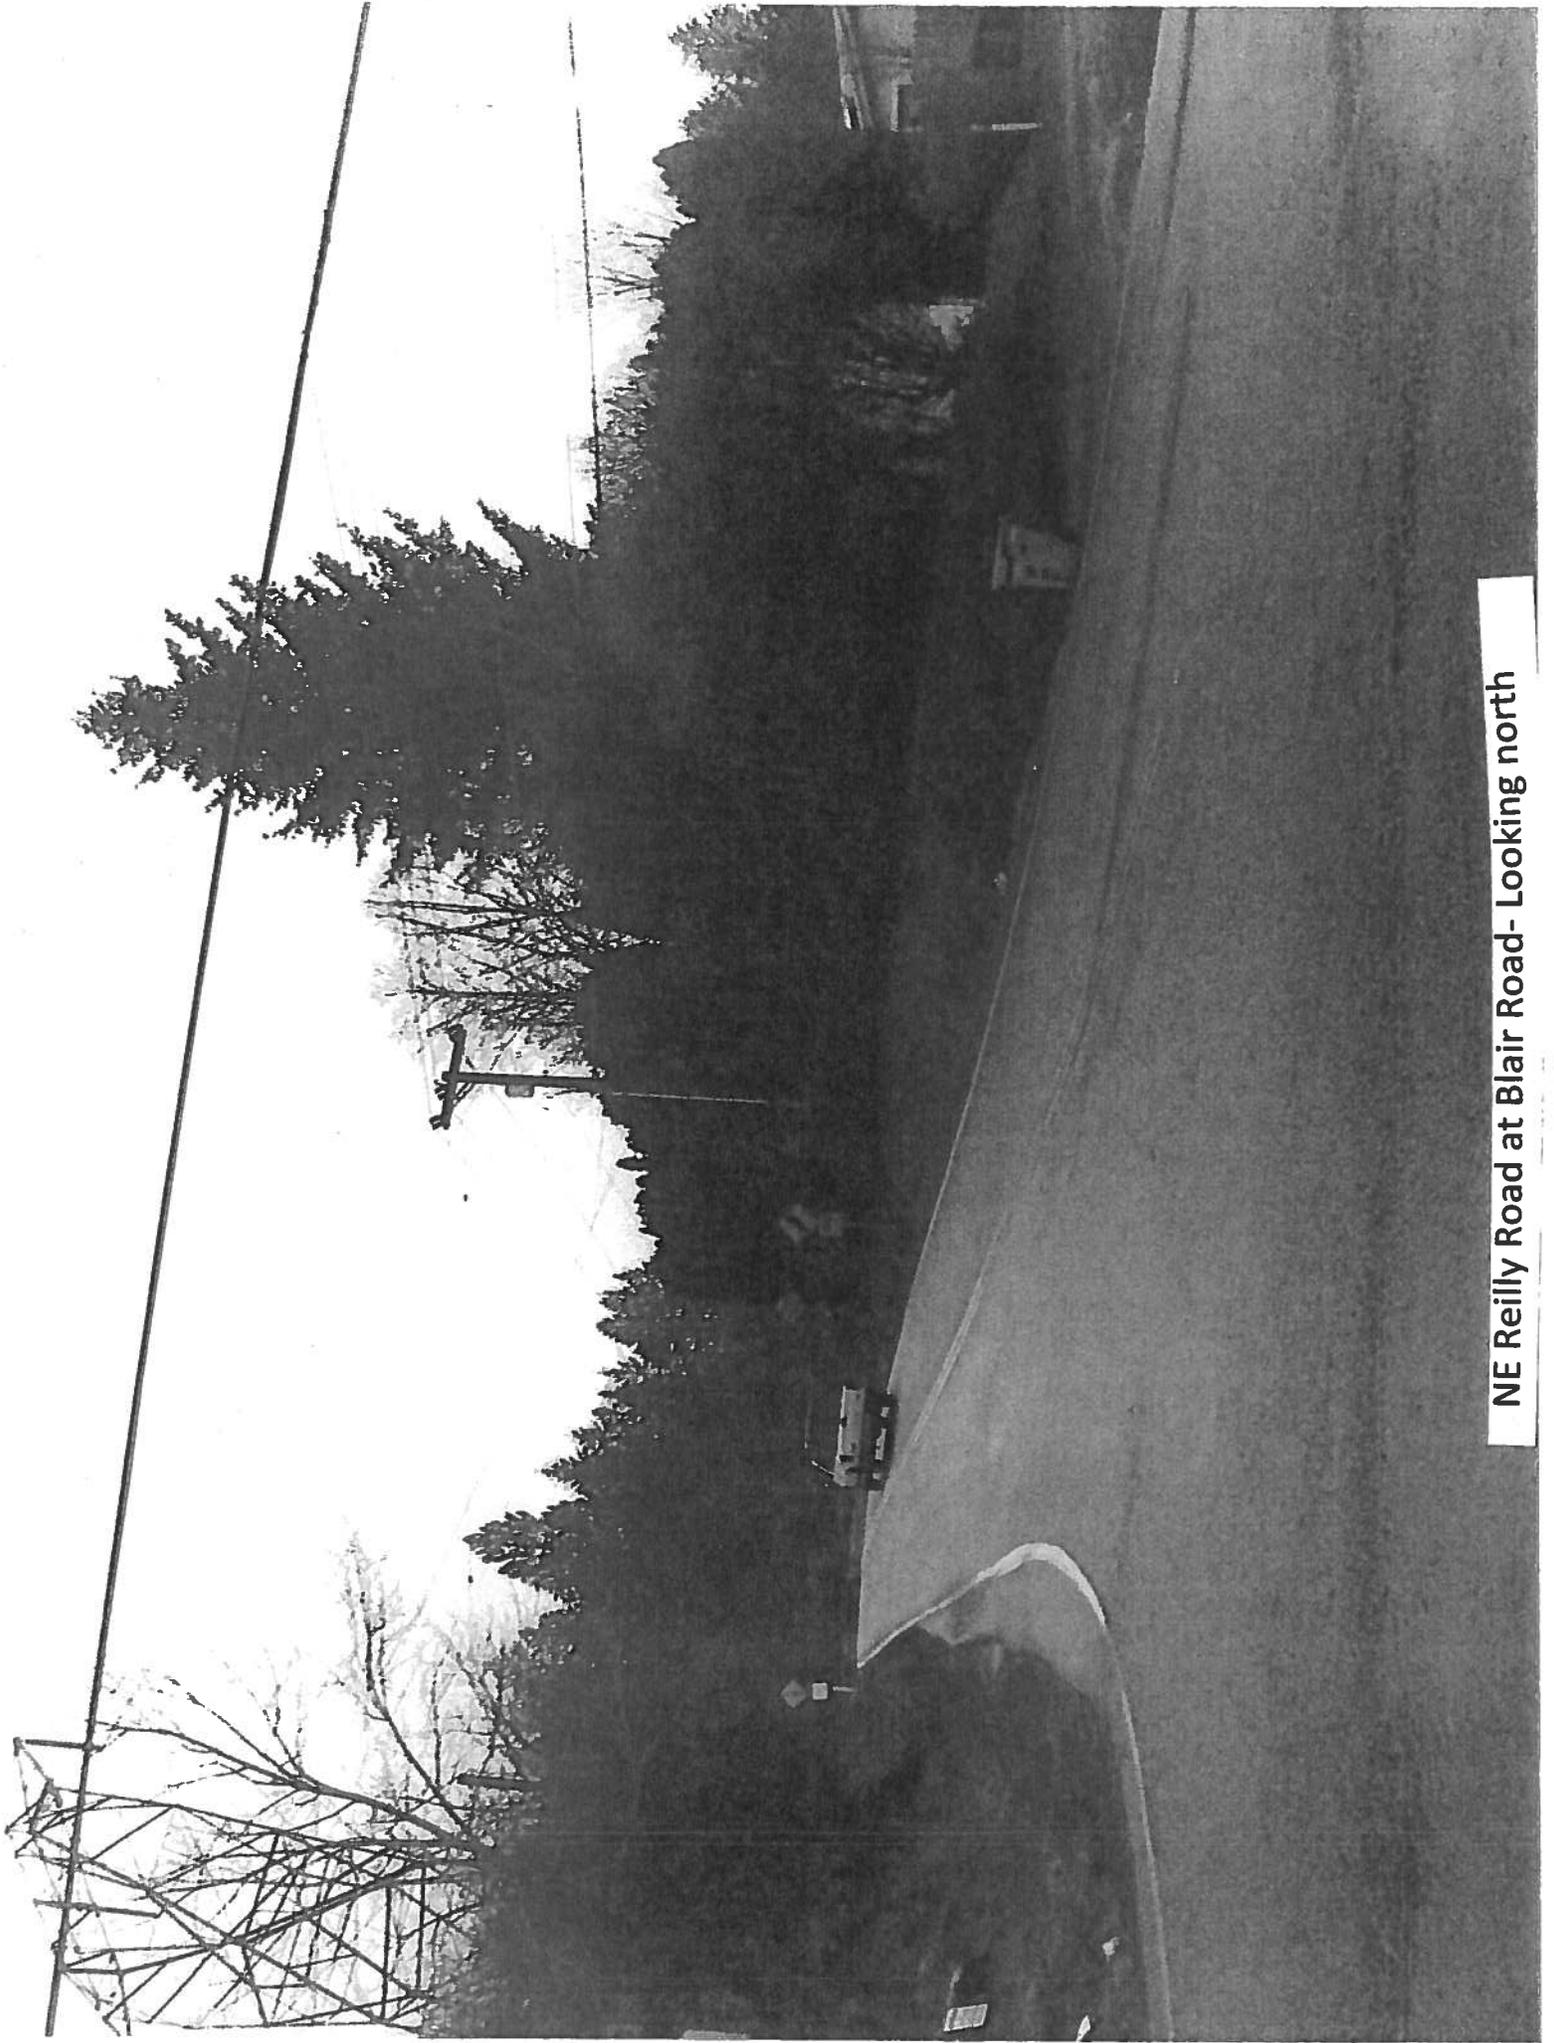
14. The Stop sign on Reilly Road at Blair Road is visible from a distance of 490 feet to allow a safe stop. A supplemental Stop Ahead sign has also been installed.

NE Reilly Road at Blair Road- Looking north

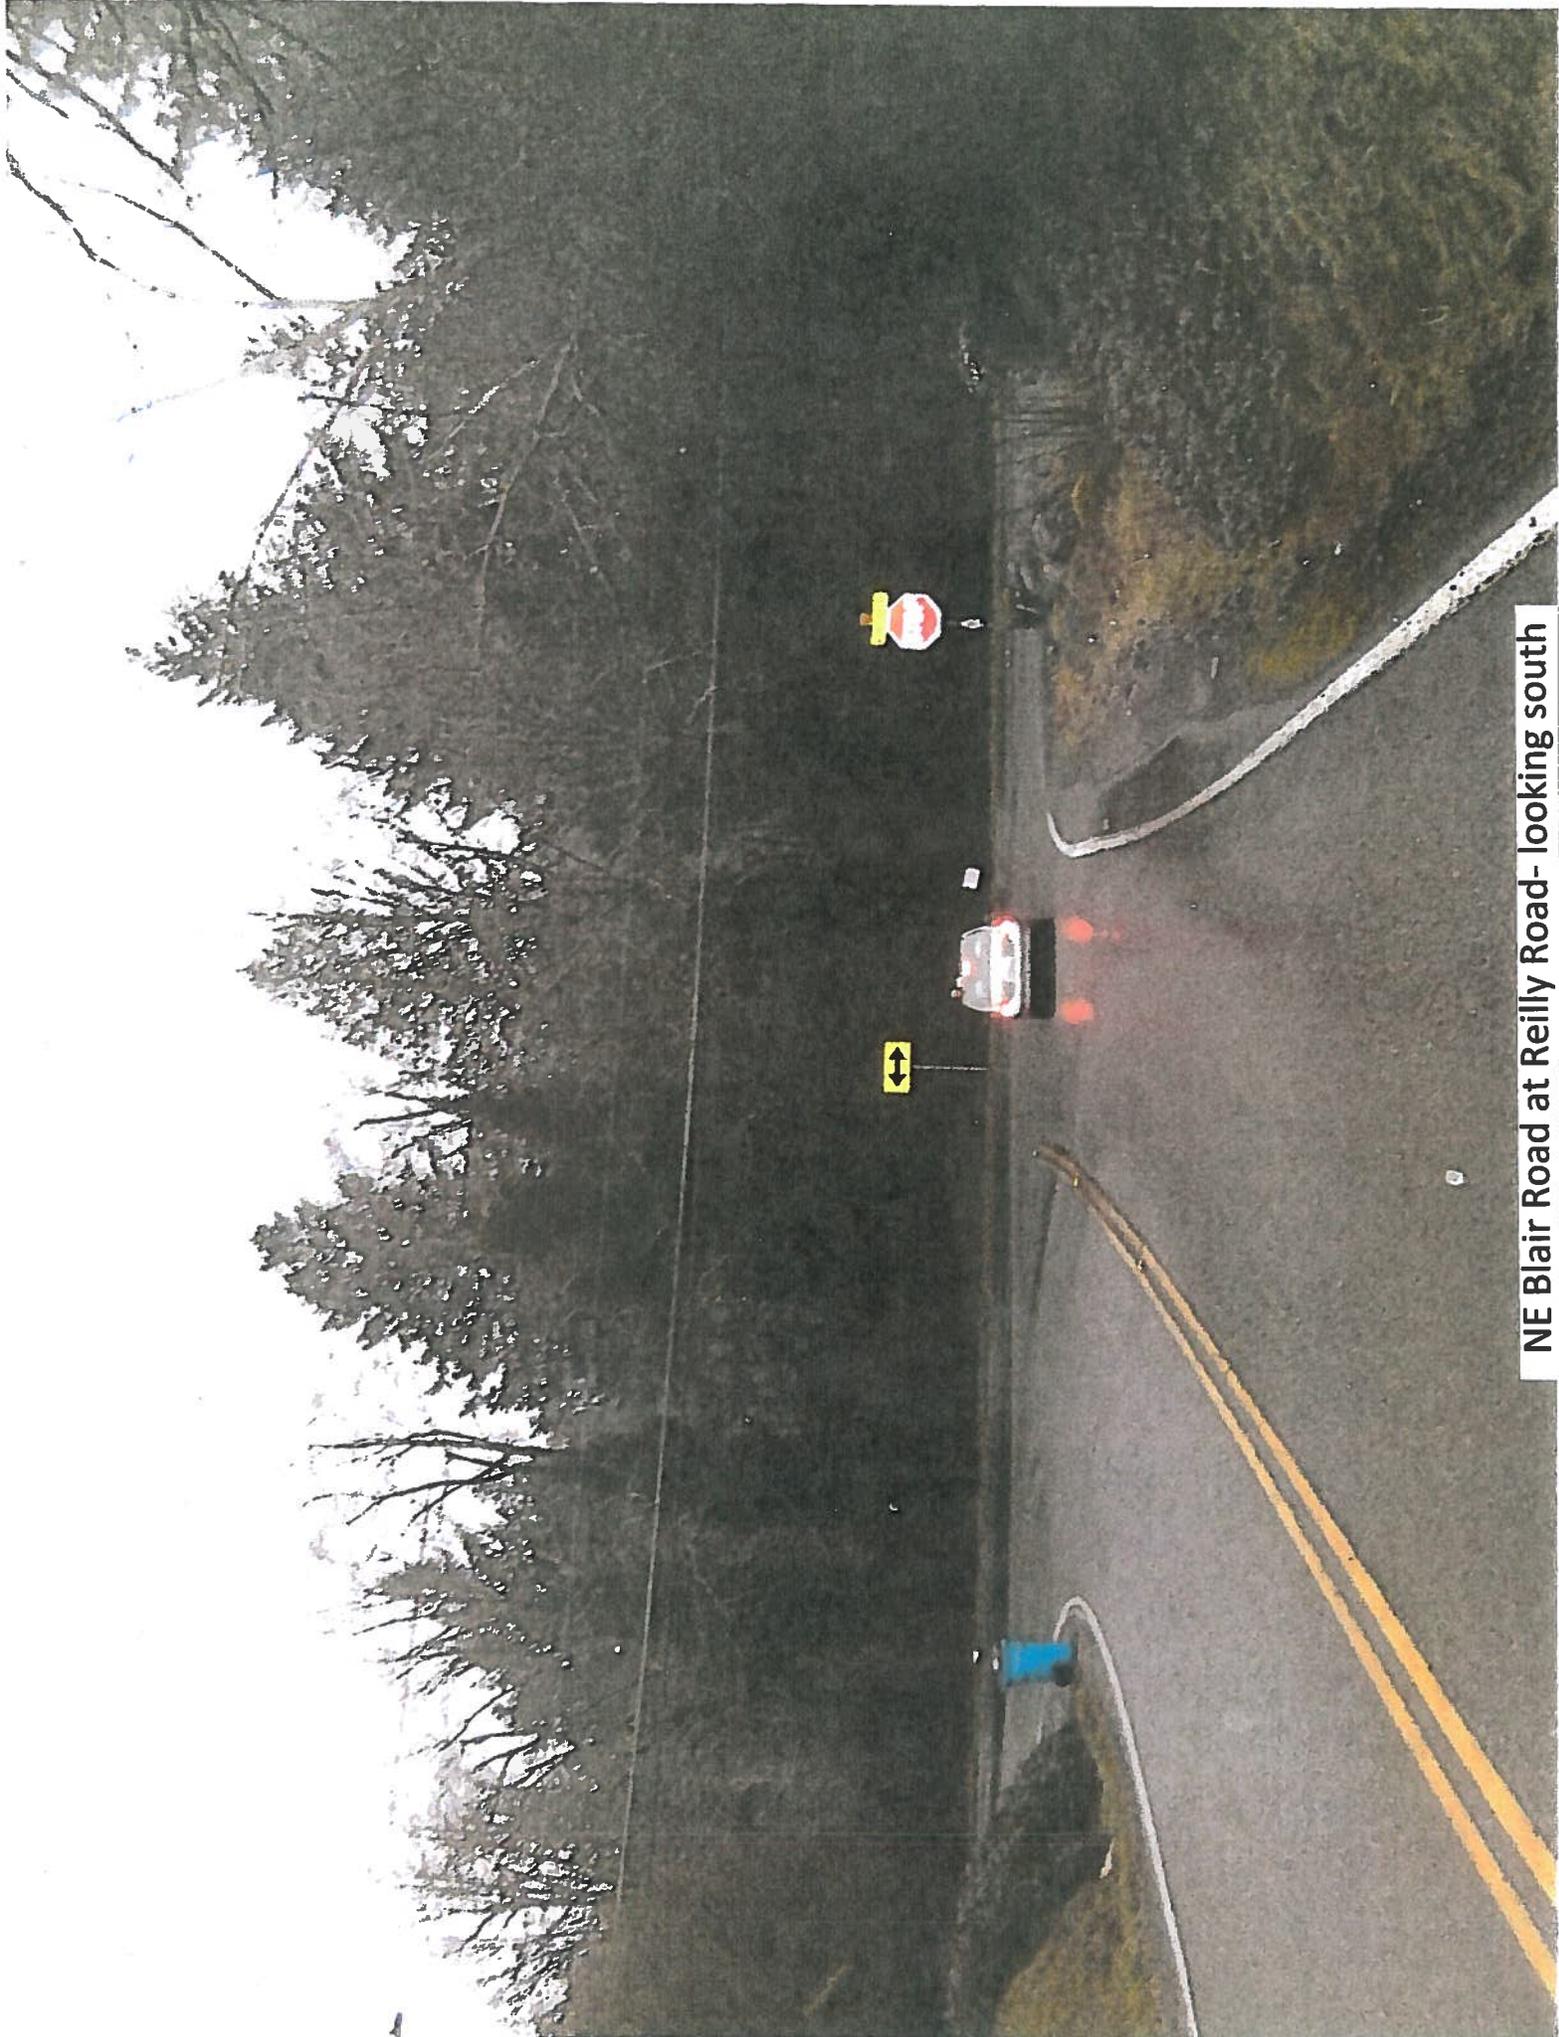
NE Blair Road at Reilly Road- looking south
