INTEROFFICE MEMORANDUM
Transportation Division

Clark County, Washington
Department of Public
Works

TO: Michael Mabrey
FROM: Ejaz Khan, P.E.; Traffic Engineer EK
DATE: December 26, 2013
SUBJECT: Livingston Mountain Quarry Overlay District.

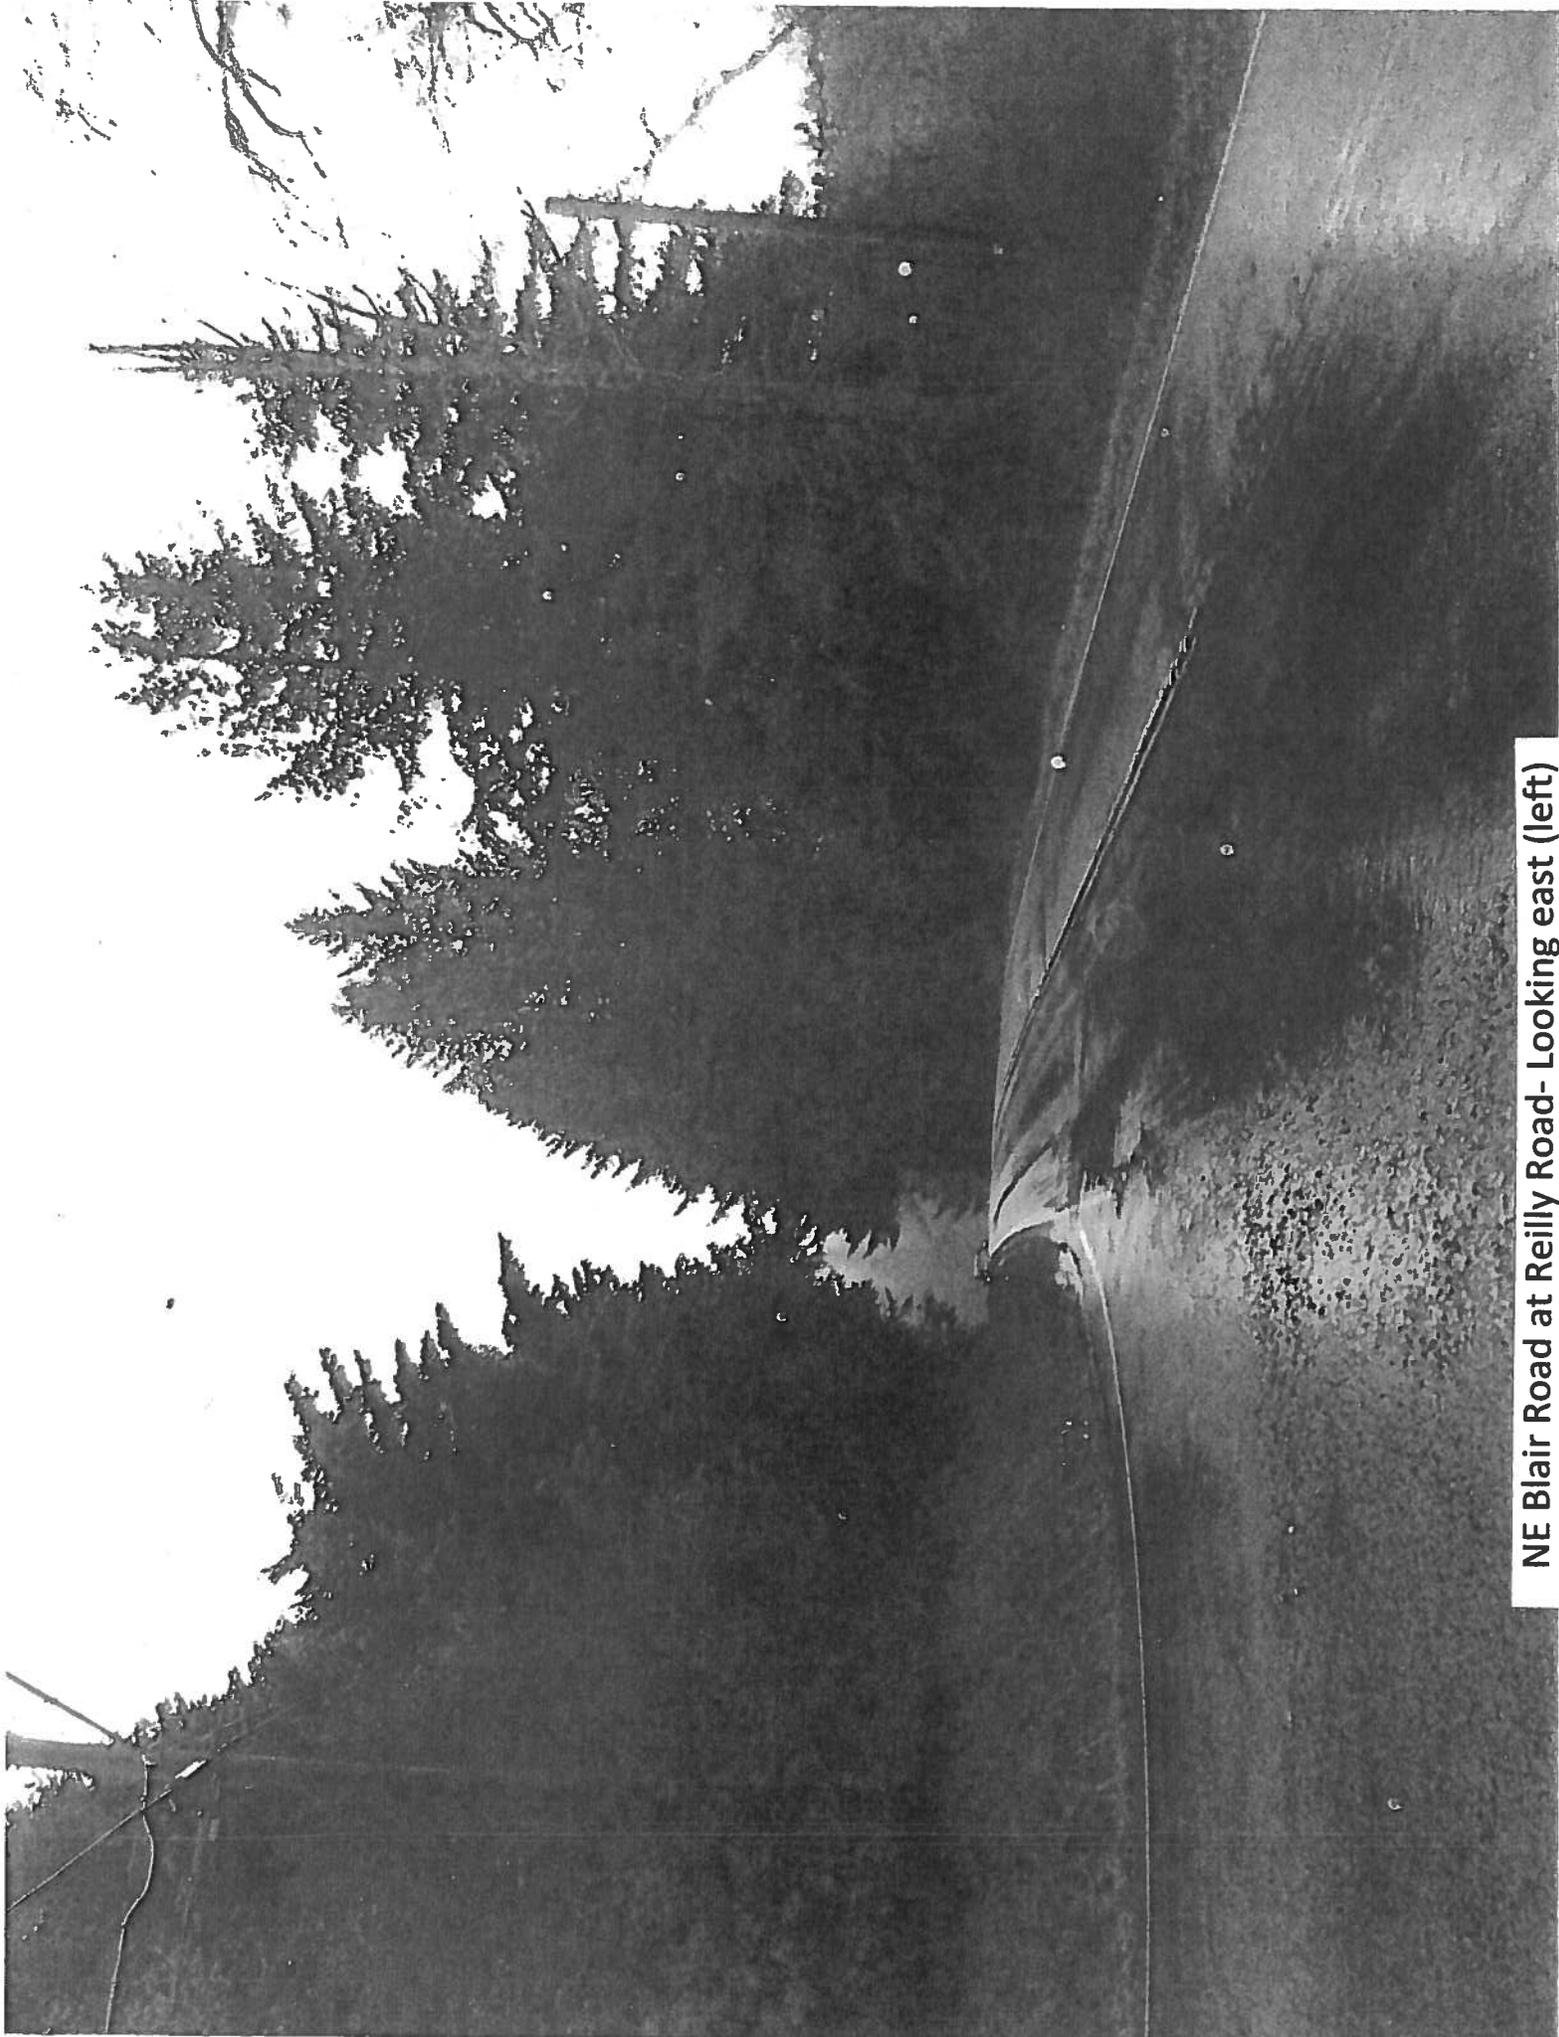
16. The intersection sight distance from Reilly Road, looking east (left) along Blair Road was measured as 320 feet. This sight distance is inadequate for making a safe left turn out of Reilly Road. The vertical curve along Blair Road restricts the available sight distance. However, a much better sight distance would be available to the truck driver since the truck driver's eye is situated at a much higher level than a regular (sedan) passenger vehicle. Proper equipment was not available at the time of field visit to determine the intersection sight distance based of truck driver eye height and data could not be recorded.

NE Blair Road at Reilly Road- Looking east (left)
